# THE LANDSLIDE AT TUVE, NEAR GÖTEBORG, SWEDEN ON NOVEMBER 30, 1977

Committee on Natural Disasters

J. M. Duncan,  
University of California, Berkeley

NATIONAL ACADEMY PRESS  
Washington, D.C.  
1980

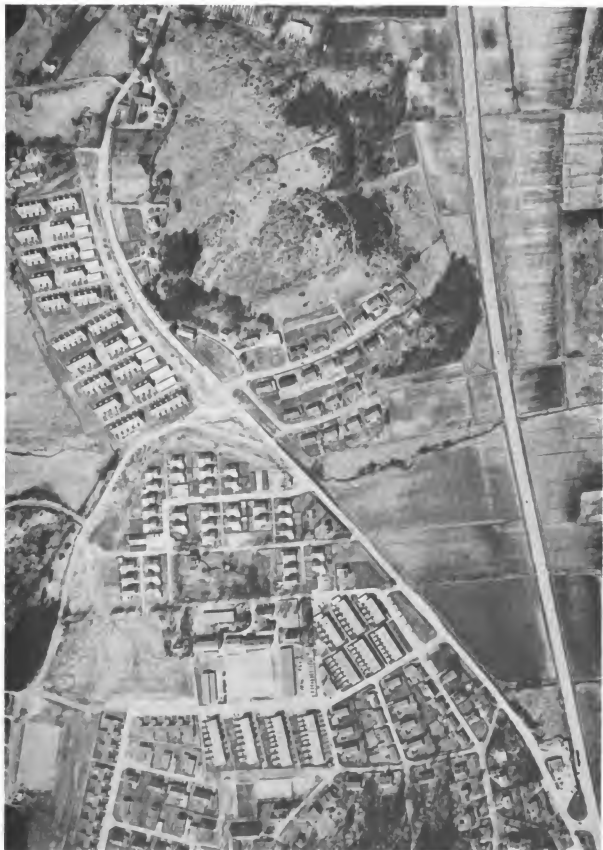
Fig. 3 Air photo of the Tuve region before the landslide of November 30, 1977.

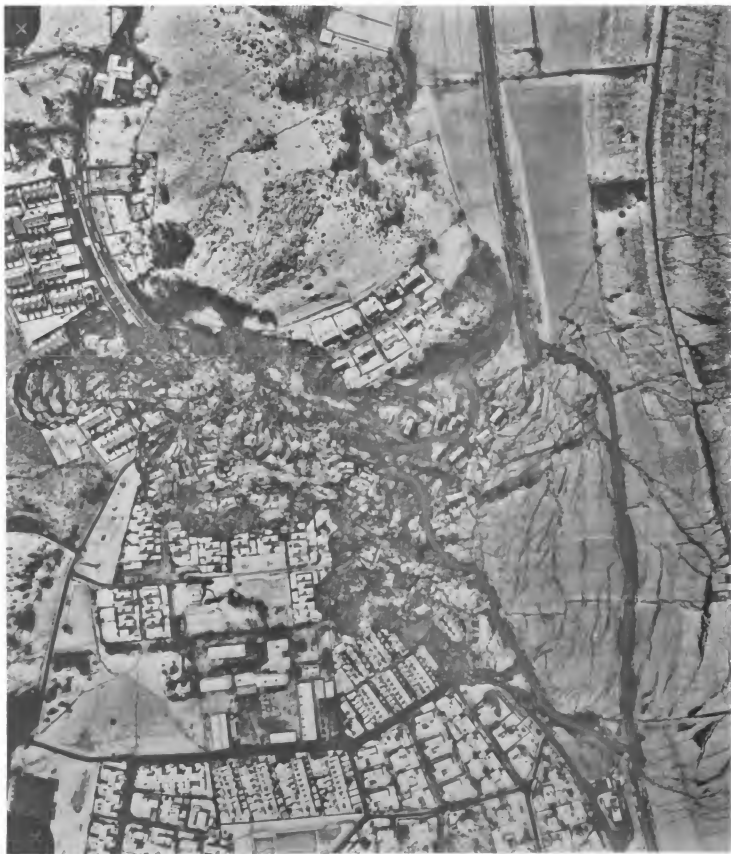
The area affected by the landslide is indicated on the topographic map (Figure 2) and may be seen in the photographs in Figures 4 and 5. The motion of the slide was from west to east, toward the main valley. The failure started with a small slide in the roadway embankment that traversed the area from southeast to northwest (Tuve Kyrkväg). From its point of beginning, it retrogressed across and up the hill; successive episodes of sliding continuing for a period of about 2 minutes. On December 3 and 4, a few minor slides occurred in the steep scarps that had been formed at the upper limits of the slide.

Fig. 4 Air photo of the Tuve region after the landslide of November 30, 1977.

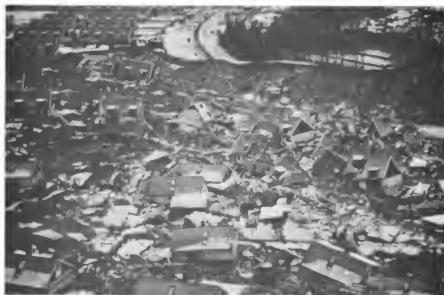
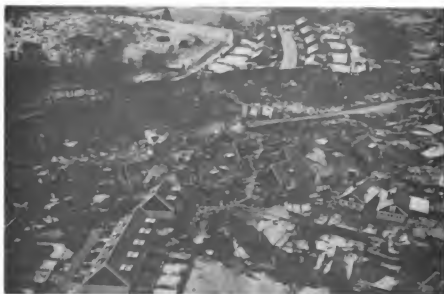
Three cross-sections illustrating conditions before the landslide are shown in Figure 7. The portion of the slide above section C-C was characterized by large displacements of the ground toward the main valley, with a consequent drop in the ground-surface elevation as the clay, flowing and sliding downhill, left a partly empty rock bowl with scattered pieces of the former landscape and houses resting at its bottom, as shown in Figure 8.

Fig. 8 Two views of the bowl formed  
at the upper part of the slide.

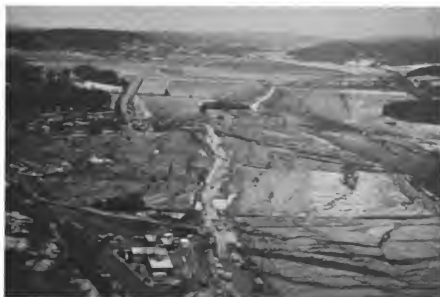
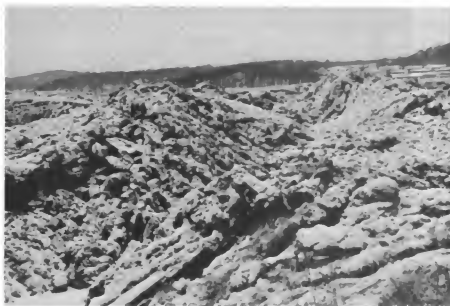
The portion of the area below section C-C also suffered large lateral movements that resulted in displacement of the road in this area about 40 m to the east, toward the main valley, as shown in Figure 9. The ground in this lower area was heaved upward and the surface was compressed, as soft clay from uphill forced itself against and beneath the stiff crust that blanketed the lower part of the slope. The bulging and compression of the ground surface in this area are shown in Figure 9.

Fig. 9 Displacement of the road and heave and compression of the ground surface in the lower part of the slide.

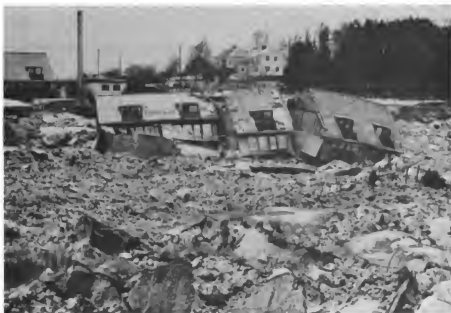
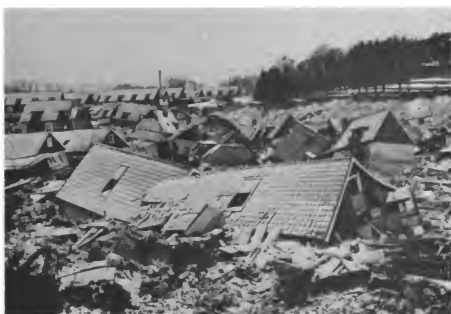
All of the houses involved in the slide were severely damaged and rendered unusable. Larger houses and row houses were frequently broken apart by the movement, and in some cases their walls crumbled and collapsed completely, leaving only the more securely braced roof structure in a recognizable condition, as shown in Figures 10 and 11.

Fig. 10 Houses in the center of the slide area.

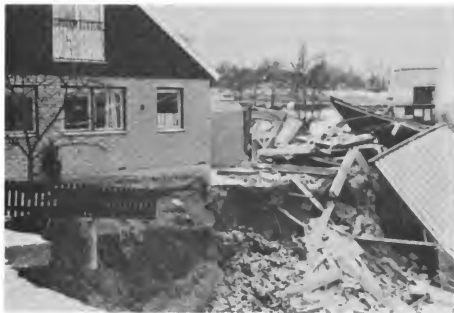
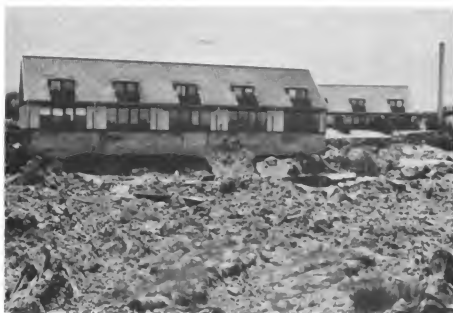
In a number of cases the slide scarp coincided nearly exactly with the wall of a house, leaving the house perched precariously at the brink of a newly formed vertical drop-off several meters high. Two such houses are shown in Figures 11a and 11b. This situation occurred with sufficient frequency to make it appear highly unlikely that it was due entirely to chance. Possible explanations are that the clay beneath the houses had been strengthened by consolidation under the added load of the houses and that the frames of the houses themselves offered additional strength or resistance to development of tension cracks around the margins of the slide.

Fig. 11 Houses near the margins of the slide.
